UNDERWATER BRIDGE INSPECTION REPORT

STRUCTURE NO. 69539
CR NO. 156
OVER THE
ST. LOUIS RIVER
DISTRICT 1 - ST. LOUIS COUNTY

PREPARED FOR THE
MINNESOTA DEPARTMENT OF TRANSPORTATION
BY
COLLINS ENGINEERS, INC.
JOB NO. 5221 (CEI 3)

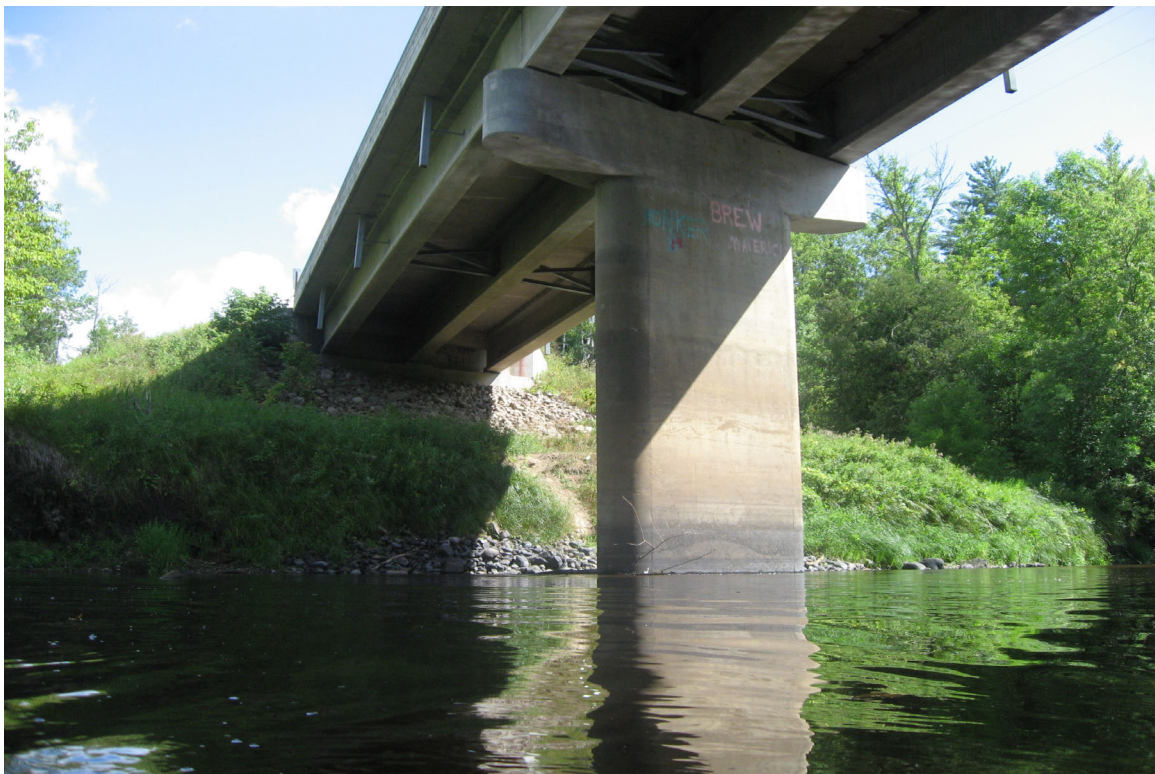
- (A) Light scaling was observed from the waterline to 3 feet above the waterline with typical penetrations of 1/8 inch and a maximum penetration of 1/4 inch.
- (B) A moderate accumulation of 2-foot-diameter-and-smaller timber debris was observed at the upstream nose of Pier 3. In addition, a 1-foot-diameter log was observed along the entire length of the east side of the pier.

Photograph 4. View of Pier 3, Looking East.

- (A) Reinspect the submerged substructure units at the normal maximum recommended (NBIS) interval of five (5) years.

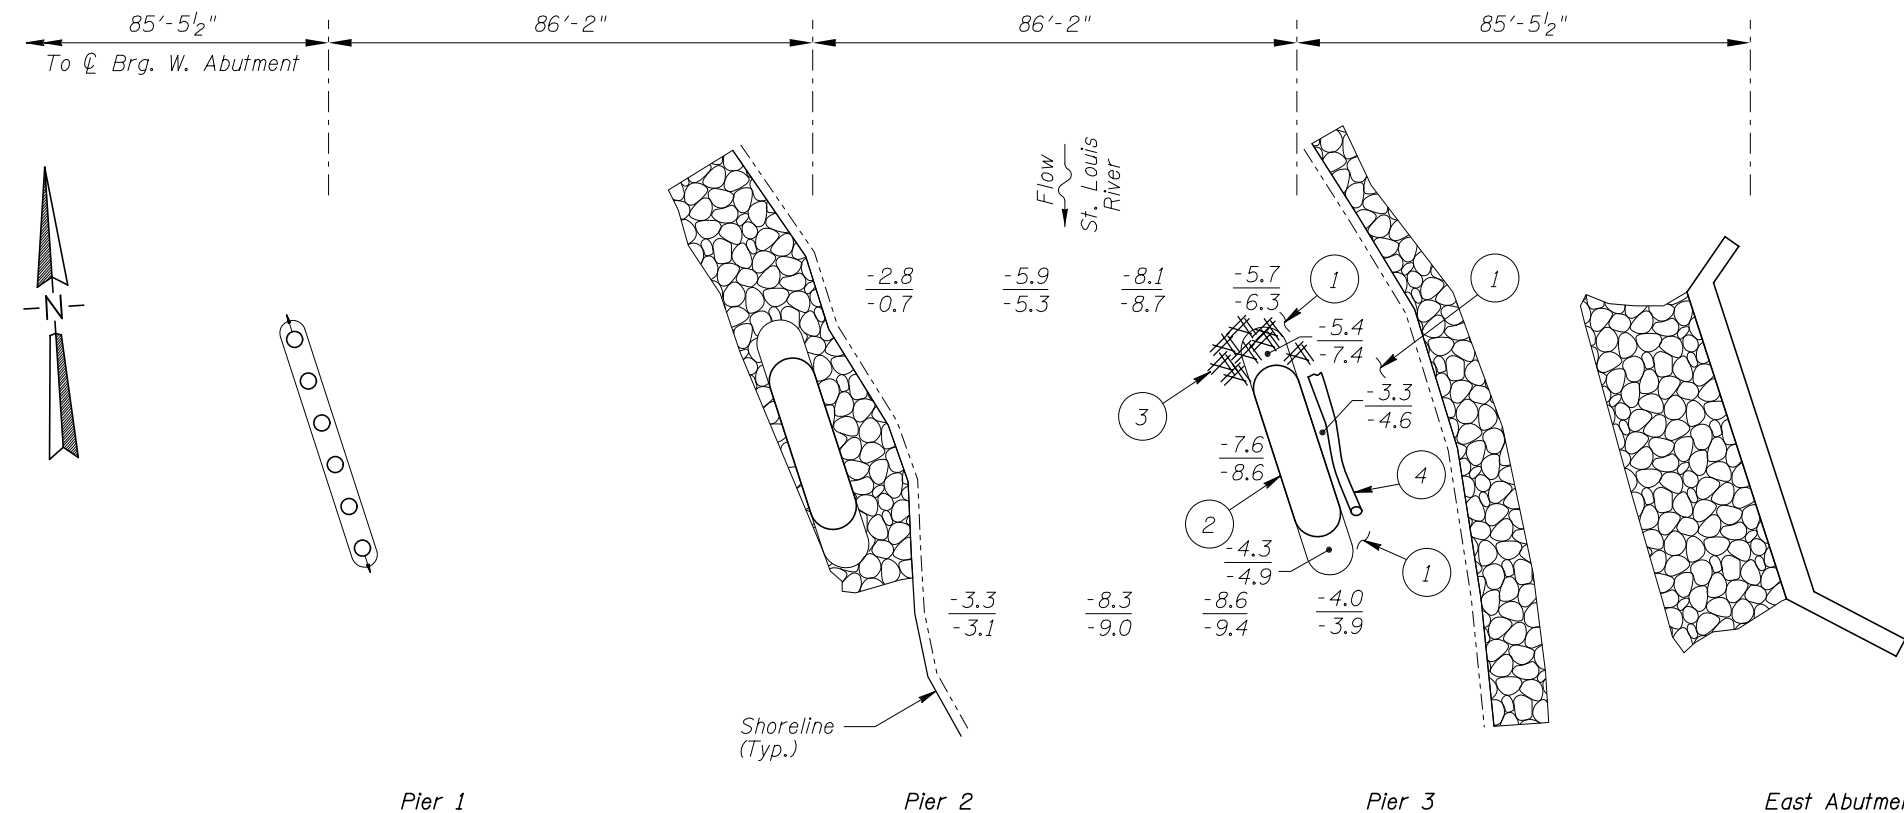
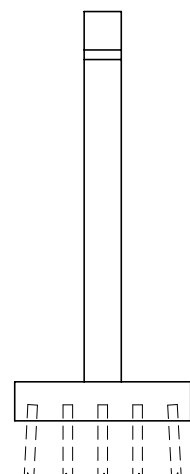
INSPECTION AND SOUNDING PLAN

- The channel bottom consisted of 1-foot-diameter riprap with no probe rod penetration around Pier 3.
- Light scaling was observed from the waterline to 3 feet above the waterline with typical penetrations of 1/8 inch and up to 1/4 inch maximum penetrations.
- A moderate accumulation of 2-foot-diameter-and-smaller timber debris was observed at the upstream nose of Pier 3 from waterline to channel bottom.
- An 1-foot-diameter log was observed along the east face of Pier 3.
